Investigation of the Corrosion of USS Monitor Artifacts

Desmond Cook and
Old Dominion University

Corrosion of the USS Monitor

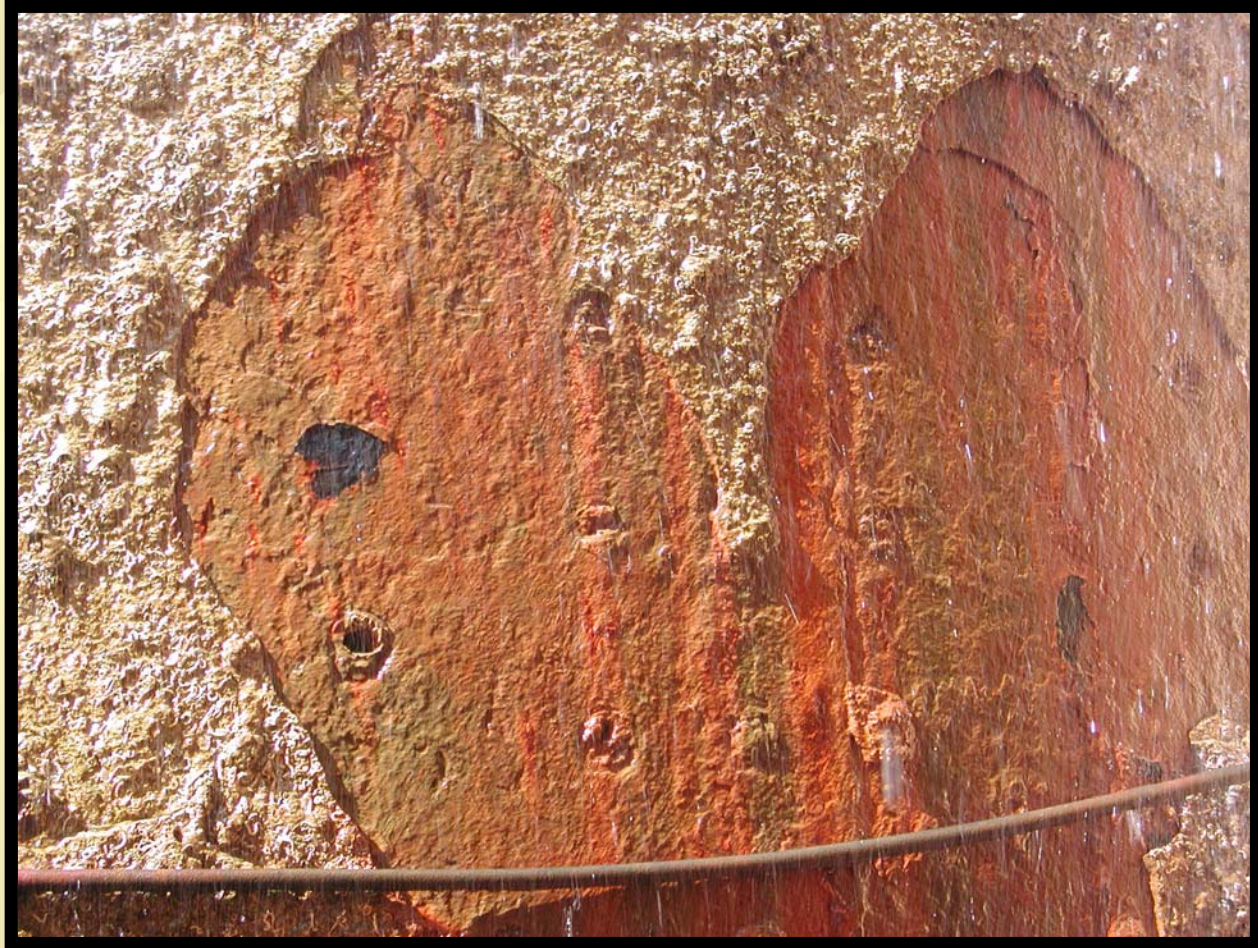
Turret rust

High Time-of-Wetness, Low oxygen, Chlorides

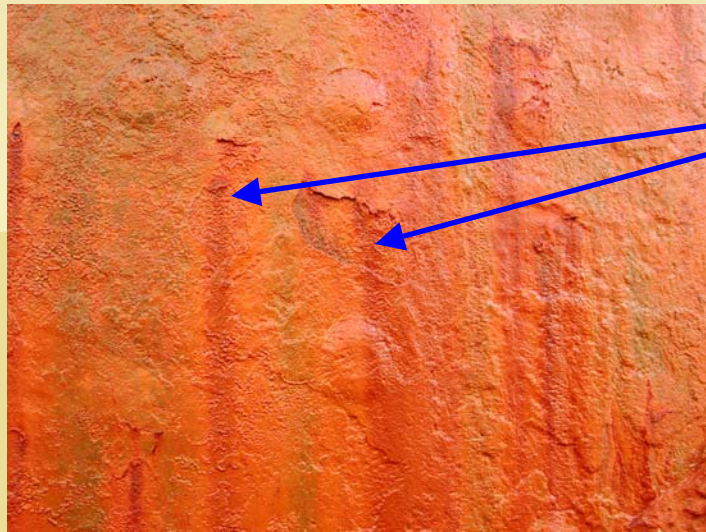
Bleeding

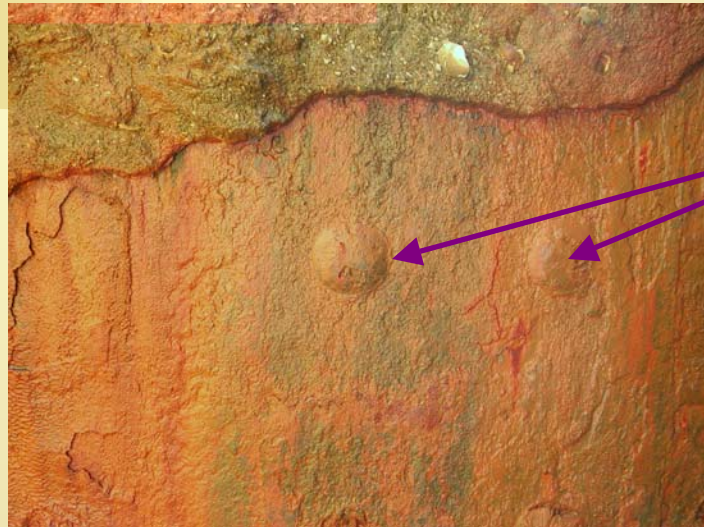
Bolt Heads

Intact

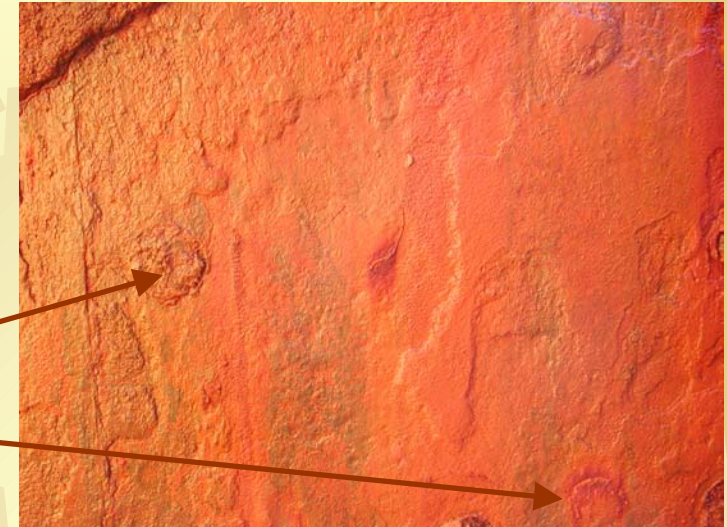
Corroded

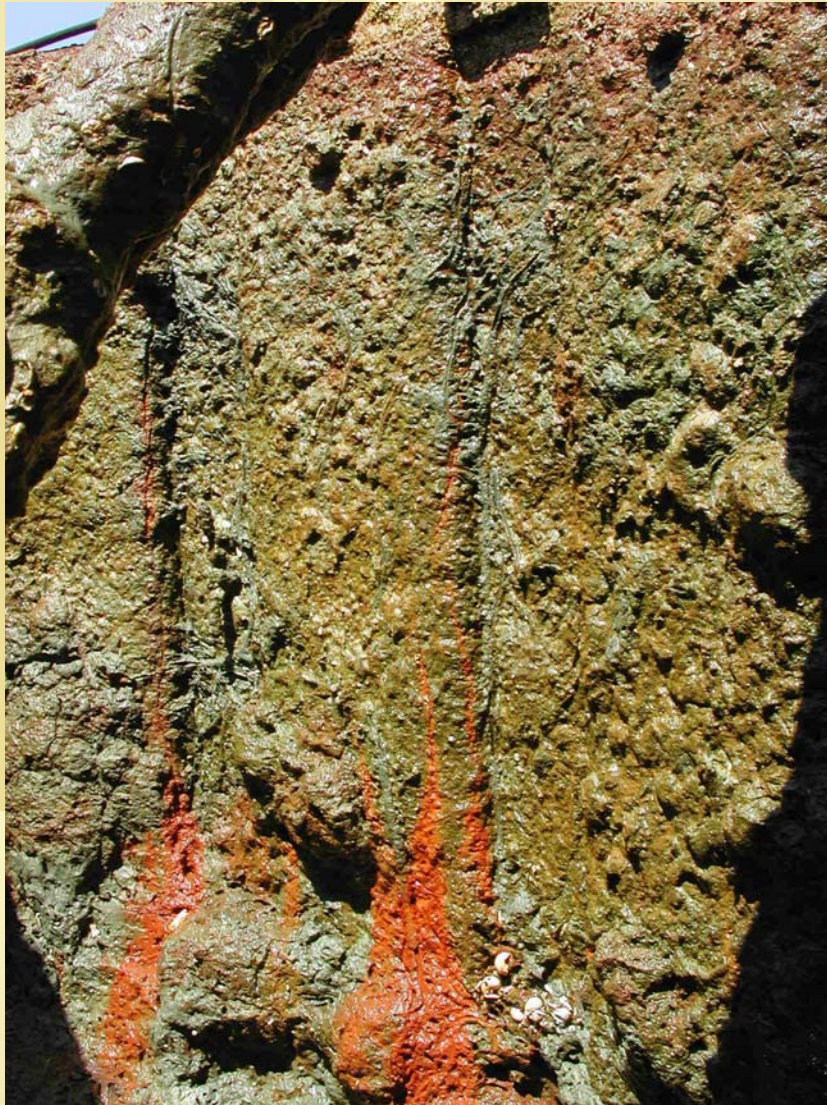
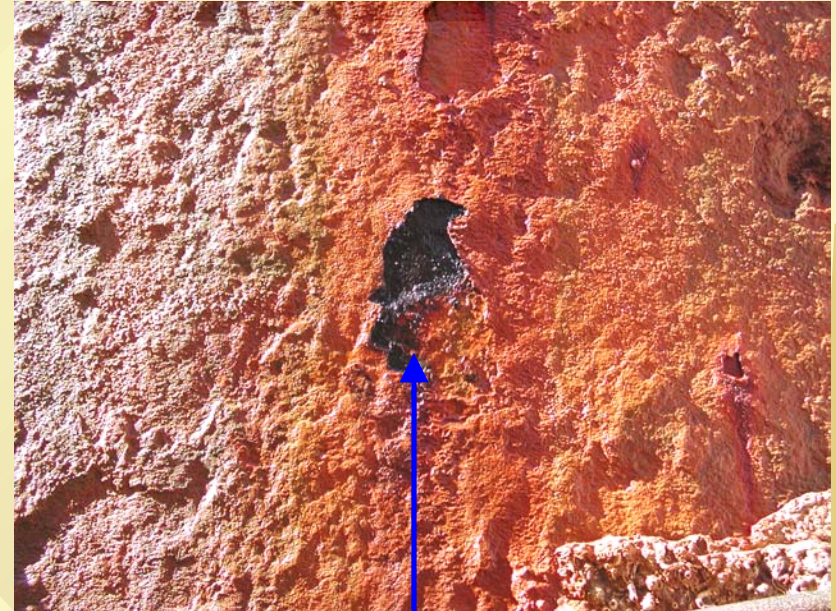
Turret Corrosion

**Submerged Corrosion Environment
(Anaerobic and salt-water)**

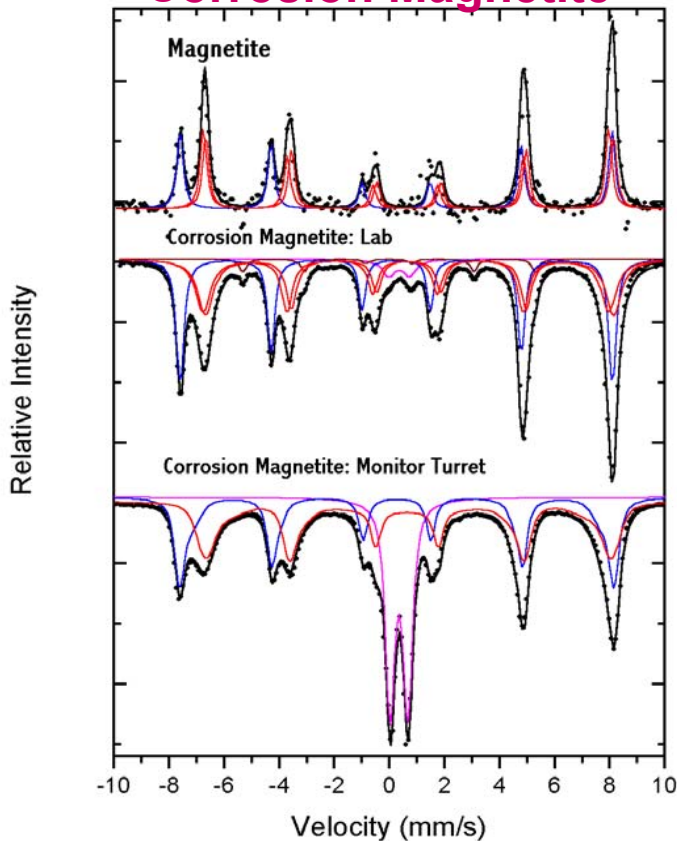
USS Monitor Turret Rust: Mössbauer Analysis

Magnetite: $\text{Fe}_3\text{O}_4 \rightarrow$ Maghemite: $\gamma\text{-Fe}_2\text{O}_3$

A new corrosion product: Corrosion Magnetite

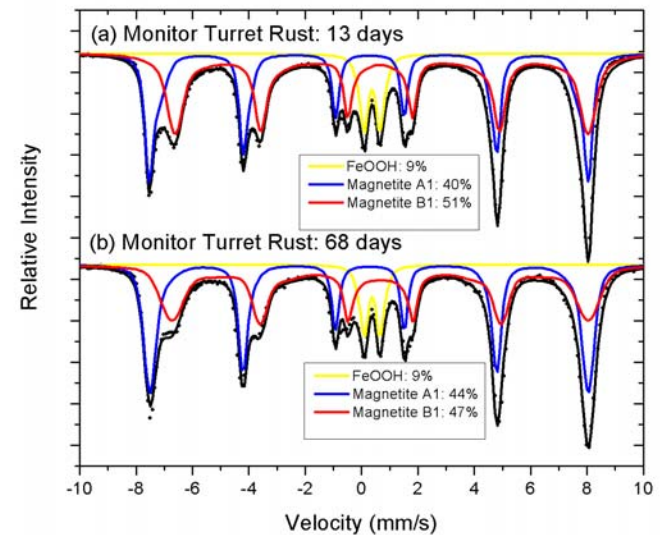
Corrosion Magnetite is unstable

As the magnetite ages,
the **B1 site** oxidizes to the **A1 site**.

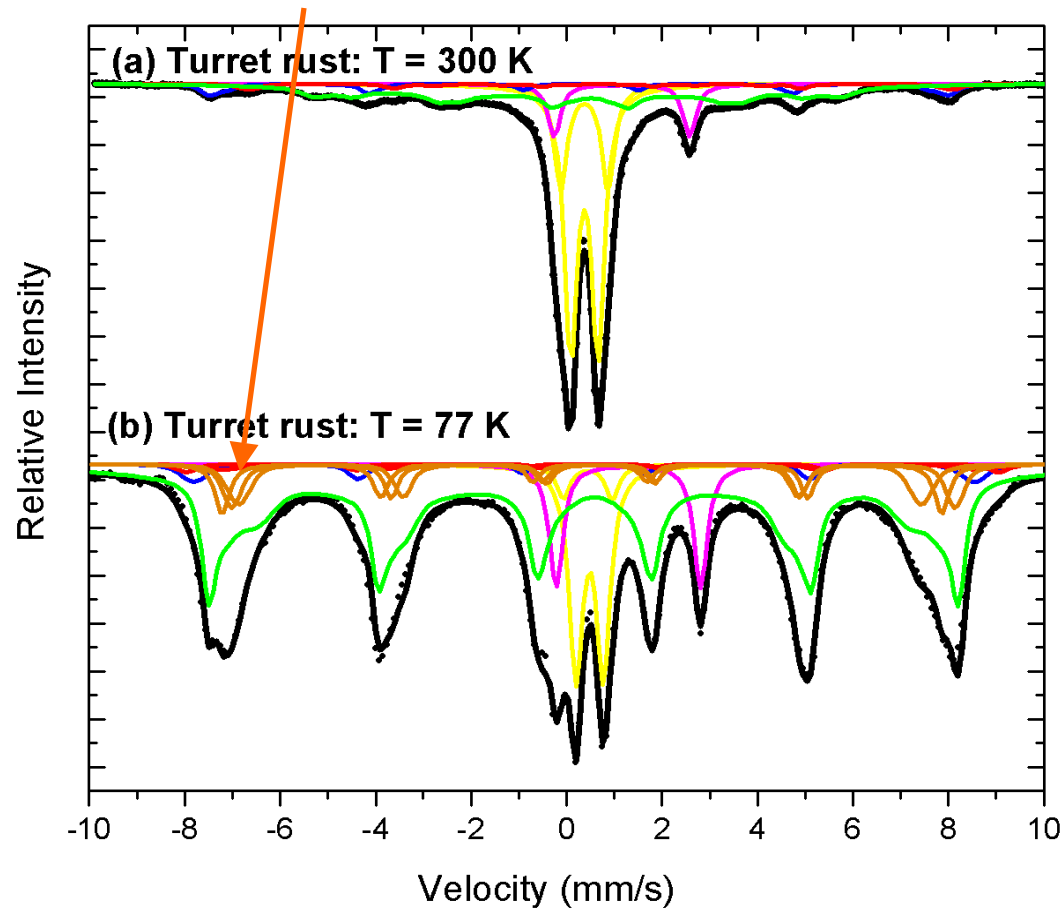
**Exterior Turret Rust: Magnetite, Lepidocrocite, Goethite,
Akaganeite +FeSiO₄ and CaCO₃**

**Corrosion mainly due to high TOW (submersion)
But exposure to air produces Akaganeite with bound chlorides**

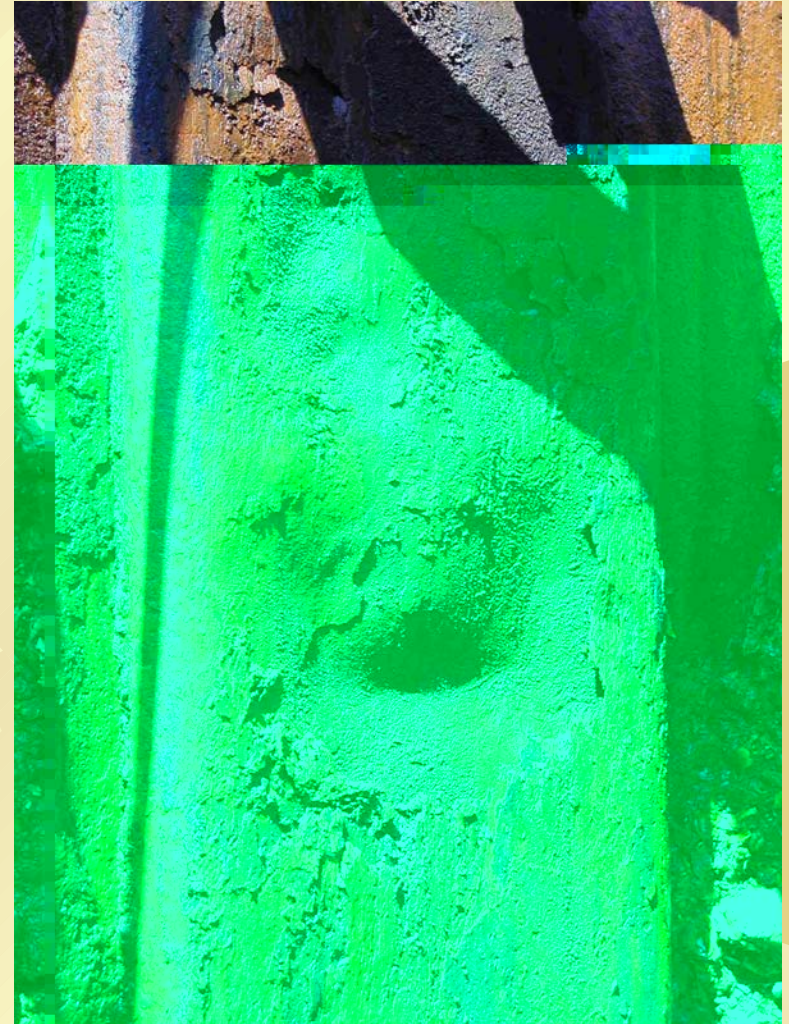
Exterior Turret Wall

Behind Nutguards

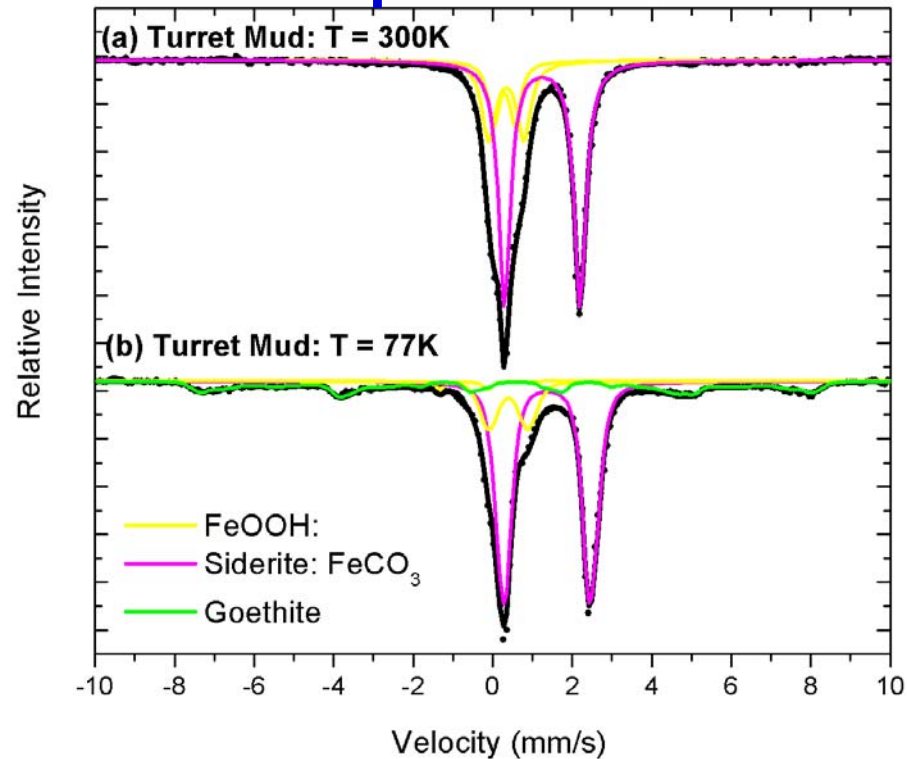
Turret Mud: FeCO₃, CaCO₃, Quartz
+ Lepidocrocite, Goethite
+ 1.5% Sulfur compounds.....MIC???
pH = 2-3

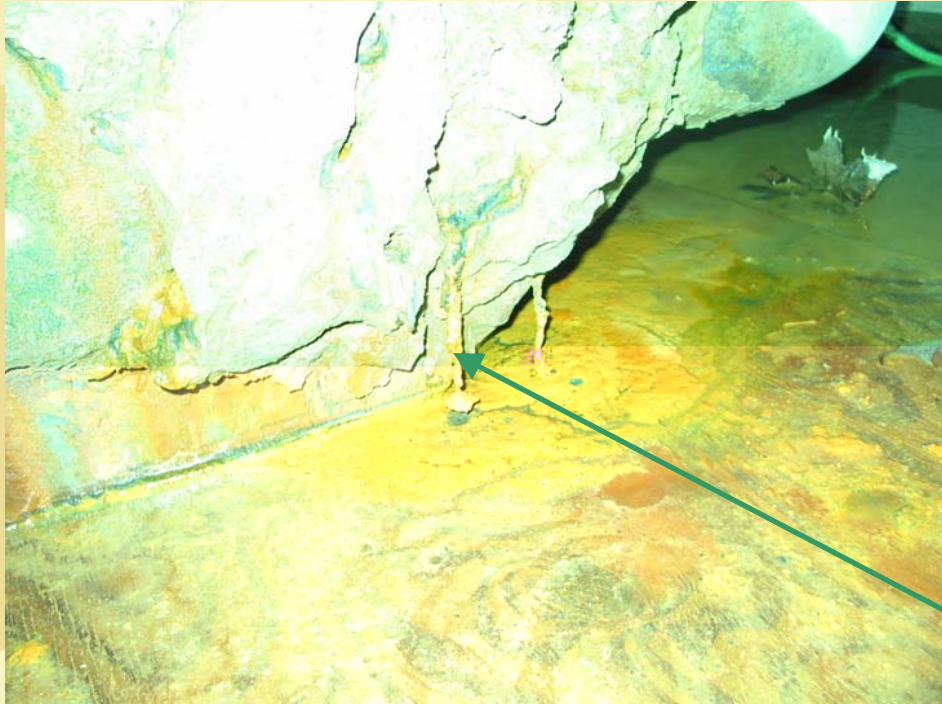
Rusticles

On Engine and Condenser

Composition:

Outer Case: CaCO_3

Inside: Mainly Corrosion Magnetite

This is in variation with Rusticle analysis on the Titanic.

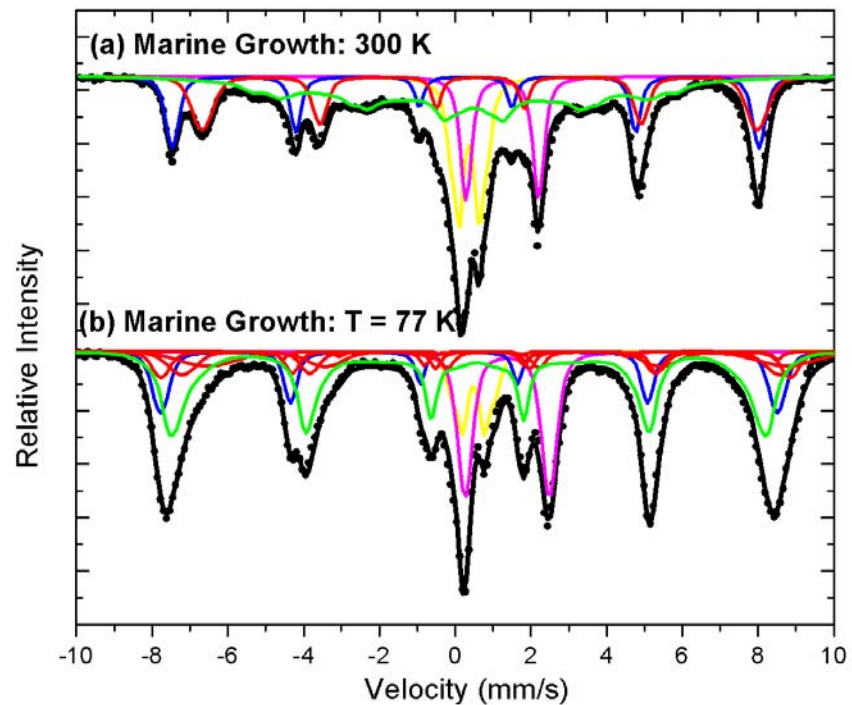
**Turret Marine Growth + Rust: FeCO_3 , CaCO_3 , Quartz
+ Magnetite, Goethite, Lepidocrocite**
