**AISI**  
**High Performance Steel Corrosion Advisory Group**  
**NYS DOT Moore Drive Bridge:**  
**Coupon Exposure Project**

**Interim Report #1**  
**Specimen Rack Construction**  
**and Installation**

## **NYS DOT Moore Drive Bridge: Coupon Exposure Project**

### **Interim Report #1 Specimen Rack Construction and Installation.**

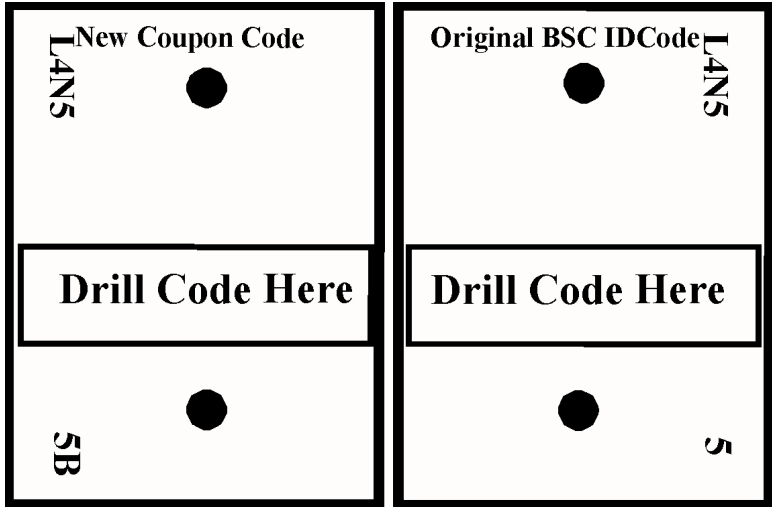
Figure 9. Location of the Coupon Drill Identification Code and two mounting holes.

Following shearing, each coupon received a 2-hole Drill Identification Code, and two mounting holes in the locations shown in Figure 9, and as can be seen in Photographs 9 and 10. A 3" x 4" stainless steel drill template was produced to accurately position the two mounting holes, and the two-hole Drill Identification Code. The Drill Identification Code followed the guidelines of ASTM G92, Standard Practice for Characterization of Atmospheric Test Sites, [7]. However the location of the holes was modified to suit the coupons being used. The template drawing, which is shown in Figure 10, contains four rows of holes, two labeled A, B and C, D and two labeled 1, 2, 3, 4, 5 and 6, 7, 8, 9, 10. The Coupon Drill Code for each coupon spans the ranges A1...A10, B1...B10, C1...C10, D1...D8, thereby covering the 38 coupons prepared, and as specified in Table II. The hole-size was 0.125". The two mounting holes were  $\frac{7}{16}$ " in diameter, which is larger than the  $\frac{5}{16}$ " holes in the Coupon Holders. The oversized mounting holes were to facilitate rubber grommets prior to mounting. The Drill Identification Code Template is stored at Old Dominion University.

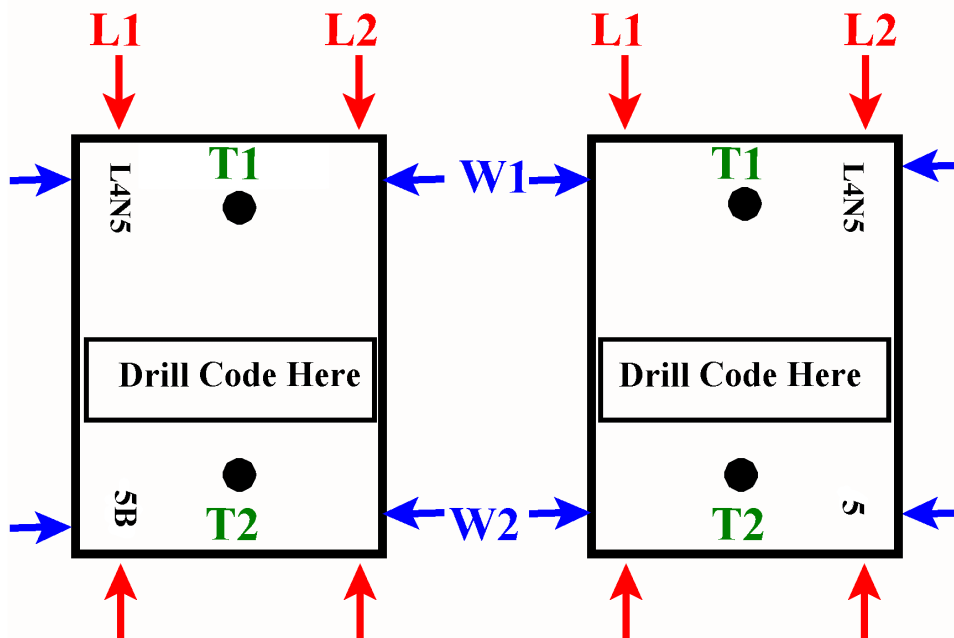
**Figure 11: Coupon Measurement Locations: Lengths L1, L2, Widths W1, W2, Thickness, T1, T2.**

Each coupon was measured prior to degreasing. The length, width (vernier) and thickness (micrometer) were measured to an accuracy of  $\pm 0.001$ ". Two measurements were recorded for each length (L1 and L2), width (W1 and W2) and thickness (T1 and T2) at extreme positions on each coupon as shown Figure 11. The data is recorded in Table II.

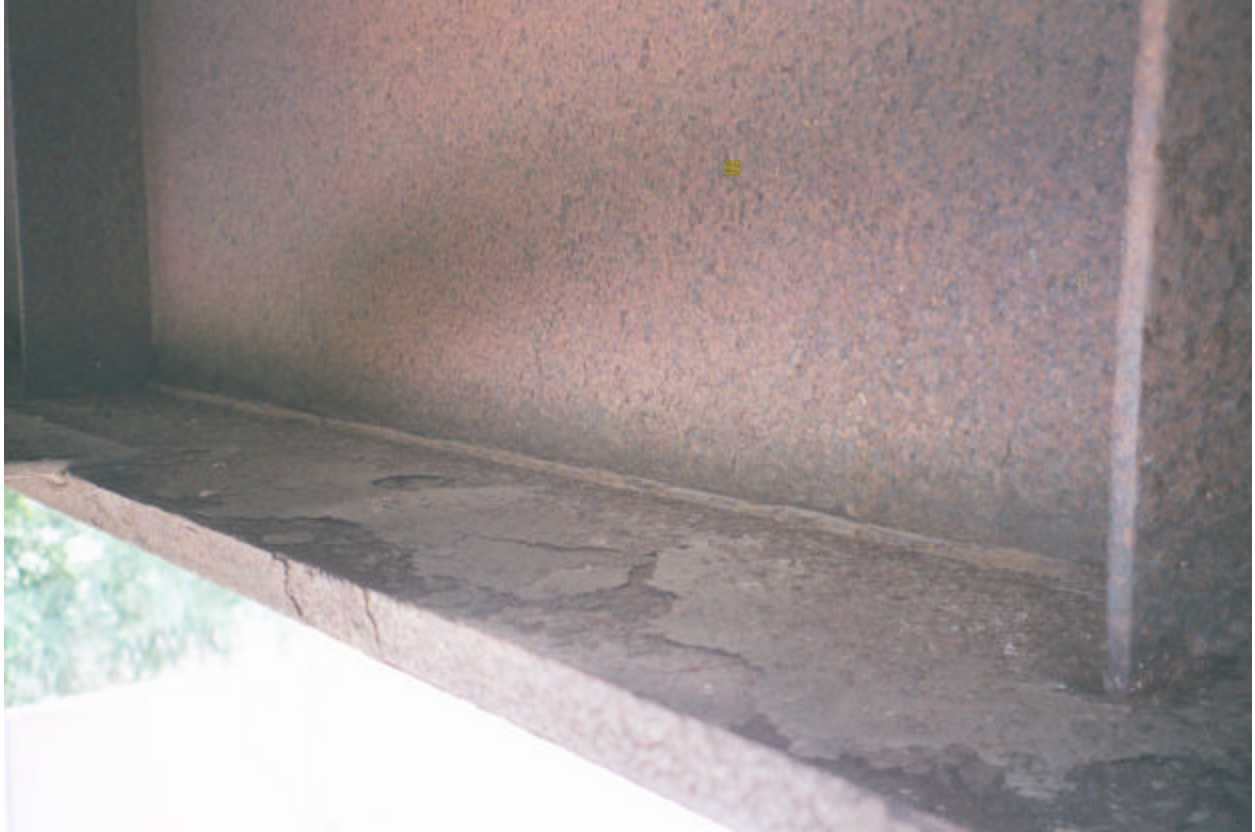
**Photograph 2:**  
**Moore Drive Bridge, Rochester NY. Corrosion of Girder 4 north web and bottom flange at location 4G (above center lane of I-390 N).**

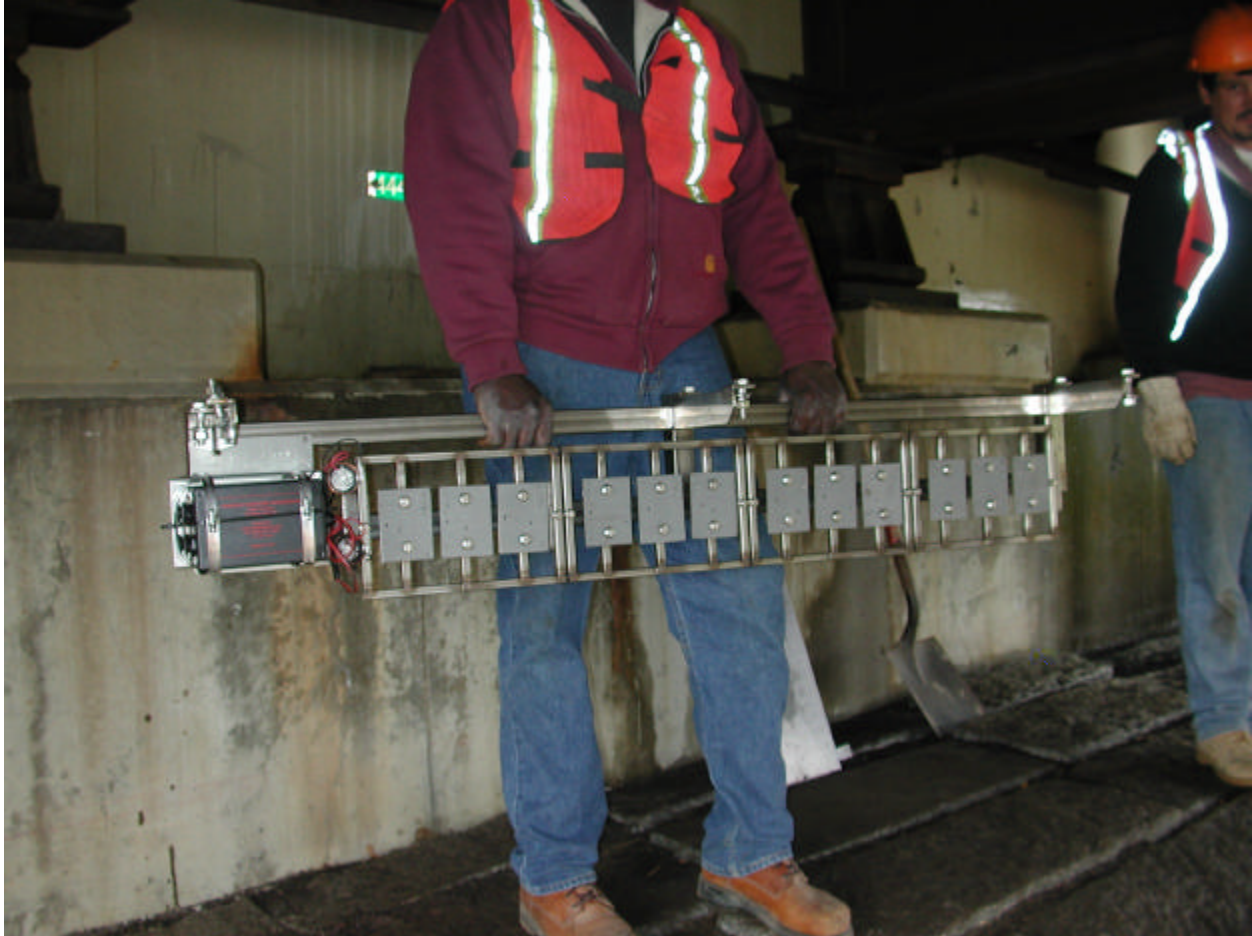
**Photograph 12:**  
**Specimen Rack 2 ready for installation with Corrosion Monitors attached. Taken at Moore Drive Bridge, West Abutment.**

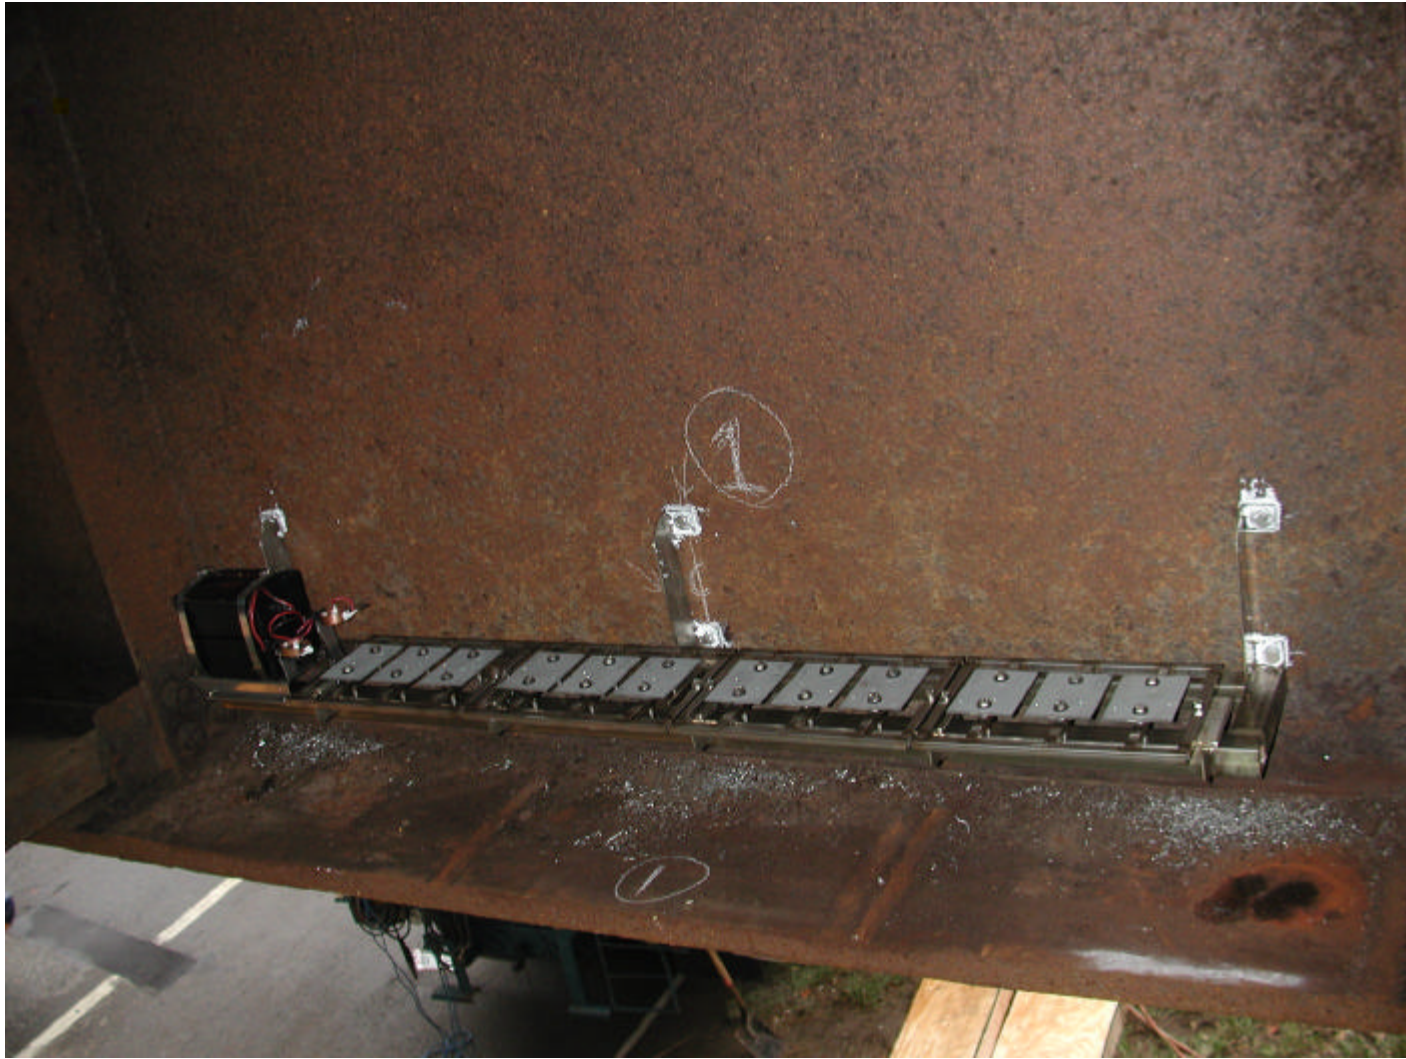
**Photograph 15:**  
**Specimen Rack 1 installed. White caulking is seen at the mounting holes.**  
**Thickness measurement positions are on the flange below each end of the rack.**

**Specimen Rack 1:** Location Code 3CN; exactly 22' 0" from the end of girder 3 at the **West Abutment** to the center of the rack. The rack was positioned between the second Intermediate Stiffener on the north web and the first Intermediate Diaphragm, from the west end, which spans girders 2 and 3 and as shown in Figure 12, Photographs 15, 16. This rack was located above the lower section of the sloped stone block paving at the West Abutment.

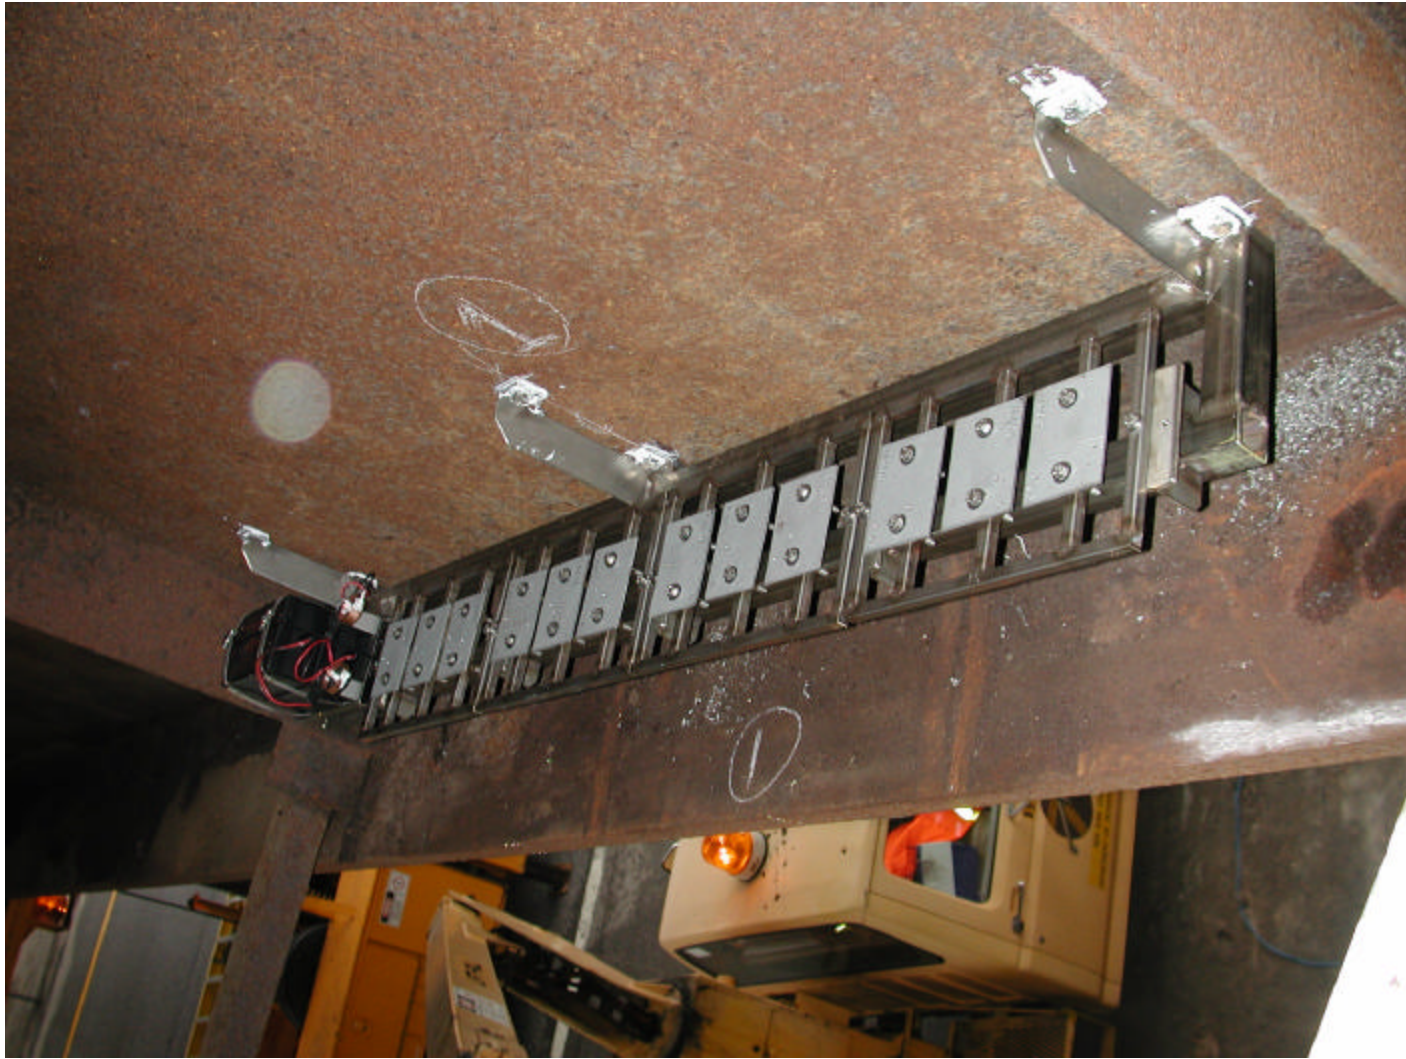
**Photograph 16:**  
**Specimen Rack 1 installed (end view), at location 3CN above west abutment.**

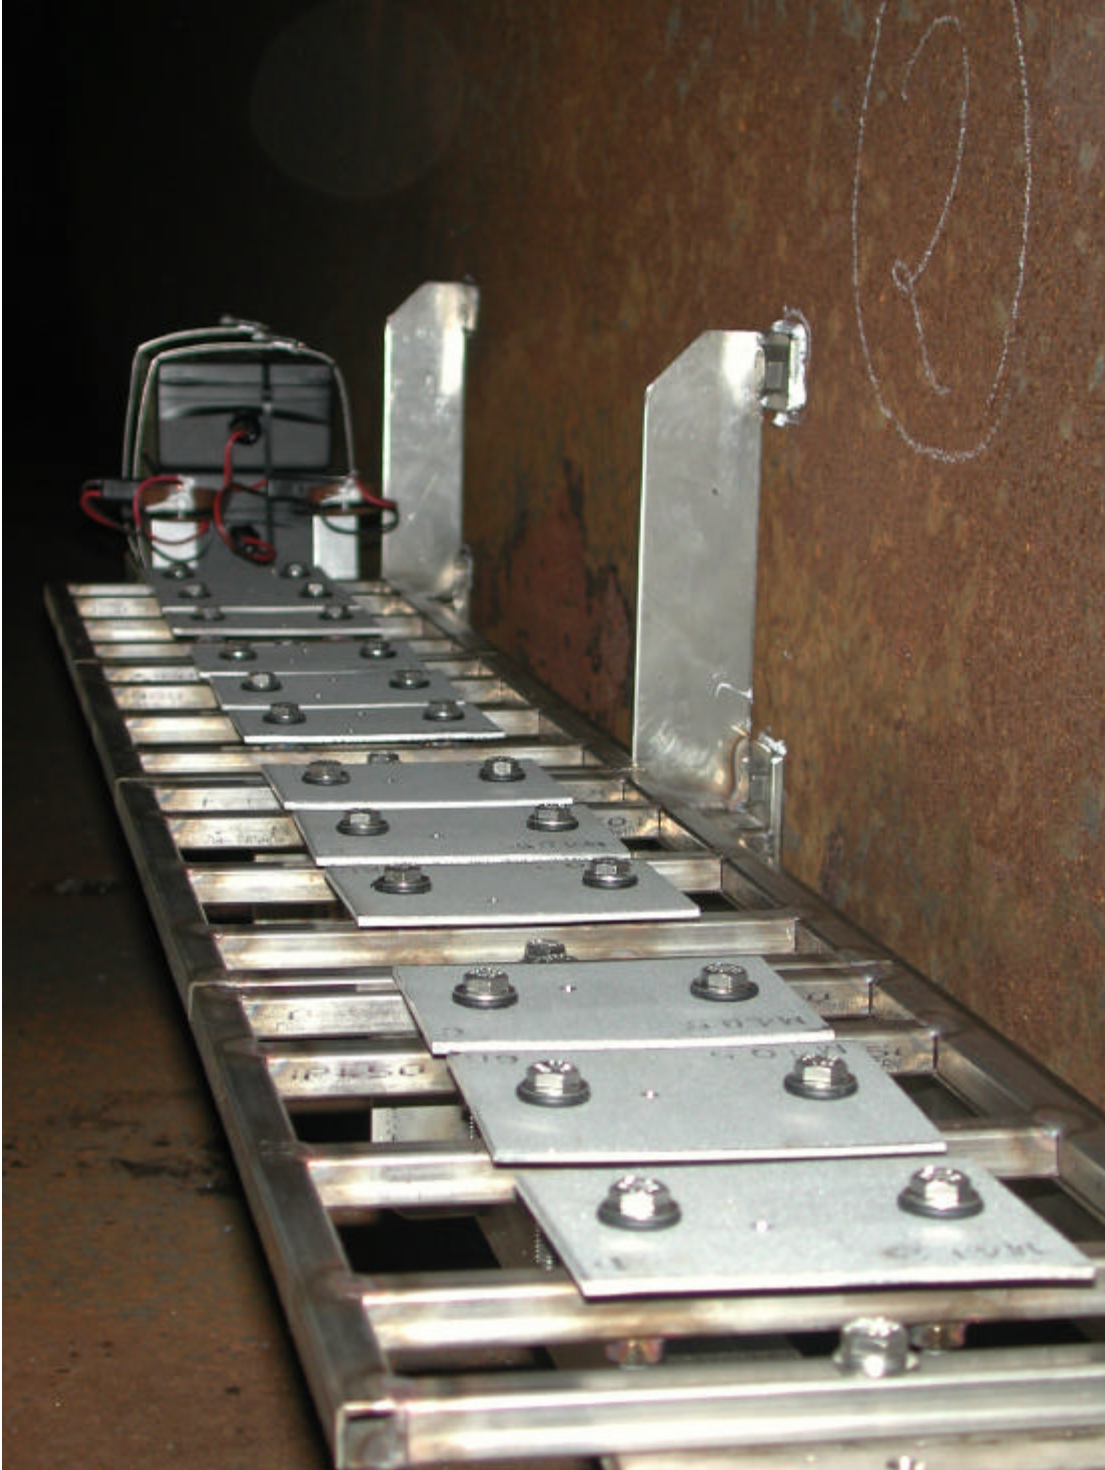
**Photograph 17:**  
**Specimen Rack 2 (end view), installed at location 3DN above**  
**right lane of I-390 S.**

**Specimen Rack 2:** Location Code 3DN; exactly 55' 0" from the end of girder 3 at the **West Abutment** to the center of the rack. This is 5 ½ east of the second Intermediate Diaphragm, which spans girders 2 and 3 as shown in Figure 12, Photograph 17. The rack is positioned above the center of the right lane of I-390 South, Photograph 18. The vertical distance from the paved road surface to the upper surface of the lower flange was measured to be 16' 4" at the center of the rack.

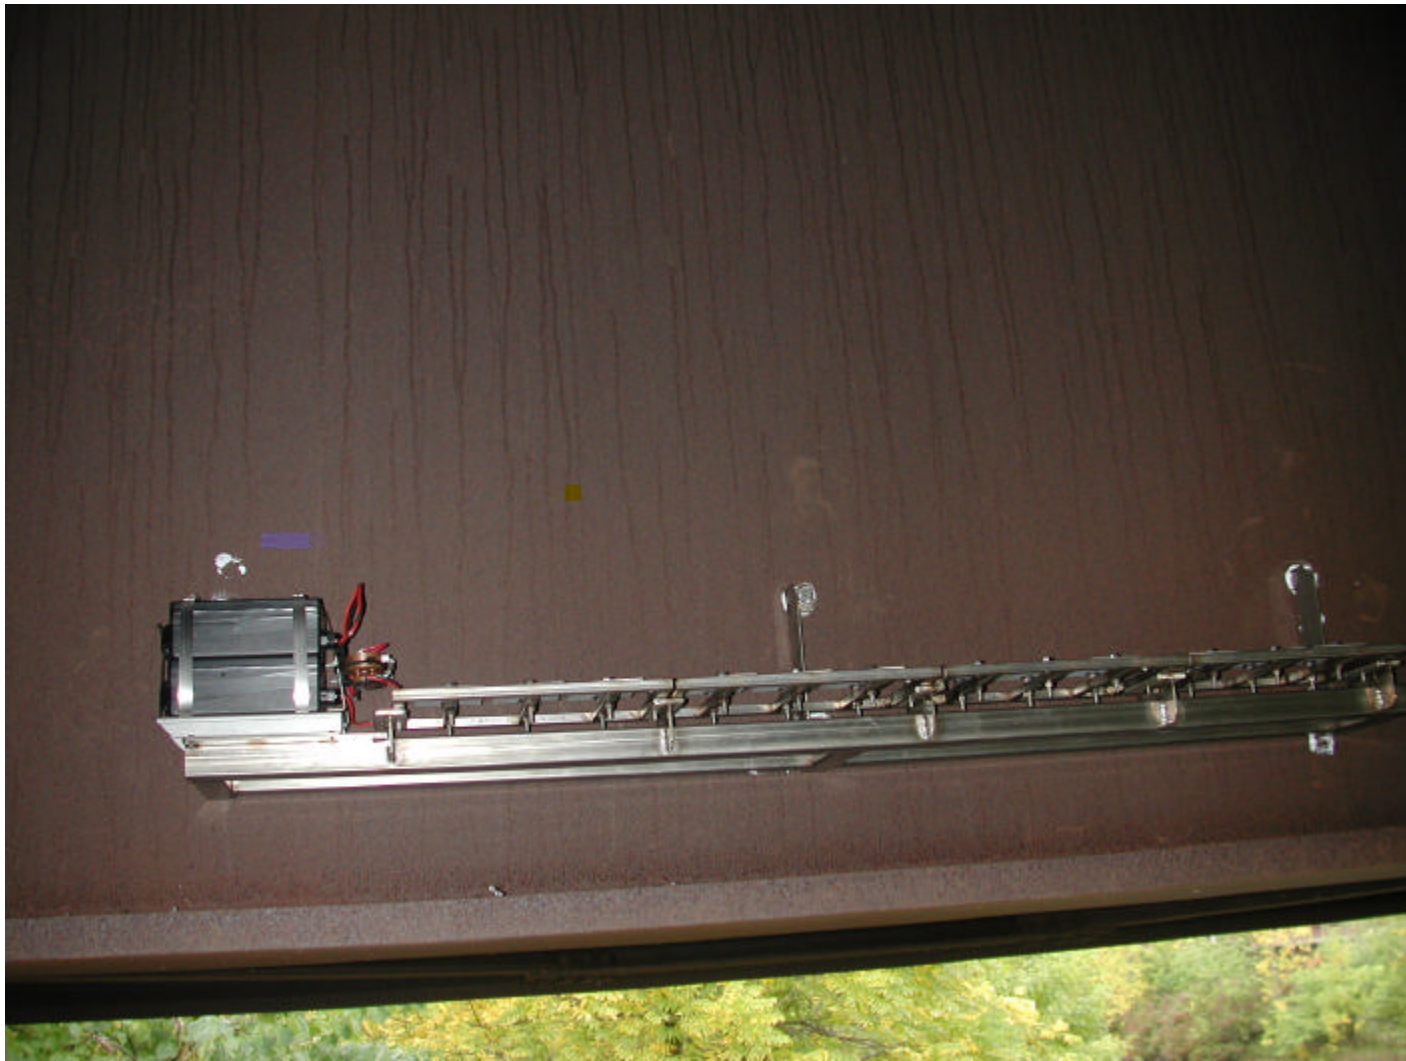
**Photograph 19:  
Specimen Rack 3 installed at location 3MN at East abutment.**

**Specimen Rack 3:** Location Code 3MN; exactly 35' 6 ½ from the end of girder 3 at the **East Abutment** to the center of the rack. The rack was positioned between the first and second Intermediate Diaphragms on the north web, from the east end, which spans girders 2 and 3, as shown in Figure 13, Photographs 19 - 21. This position is over the jogging path along the edge of the Erie Canal, Photograph 22. It is mentioned that the originally planned location for this Rack 3 was 22' from the East Abutment to mirror the location of Rack 1 at the West Abutment. However, due to the vandalism at this end of the bridge, mainly graffiti, and the ease at which people can step up to and walk along the bottom flanges, it was decided to move the rack as far as practicable from the abutment, that being at the edge of the canal. Placing the rack to the west side of the first Intermediate Diaphragm increases the difficulty of vandalism to the rack. NYSDOT cut the "grab bars" off the side of the girder to reduce vandalism. The vertical distance from the paved jogging path to the upper surface of the lower flange was measured to be 15' 8" at the center of the rack

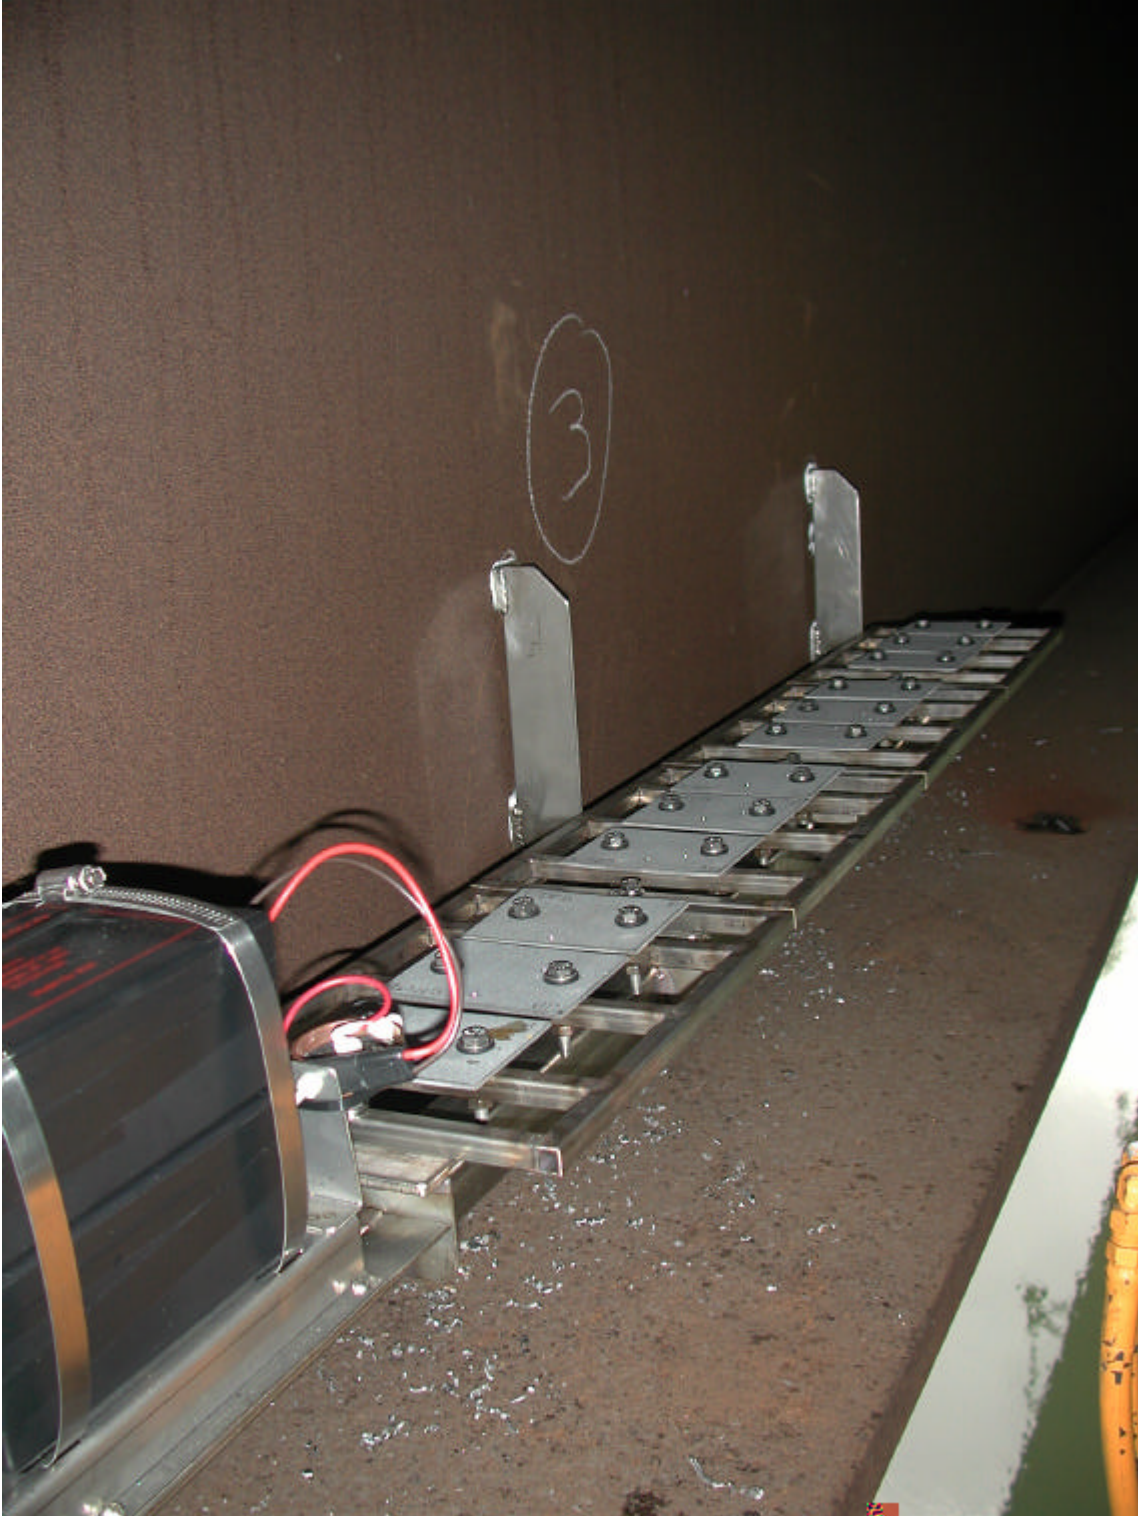
**Photograph 20: Specimen Rack 3 installed at location 3MN at the East abutment. Thickness measurement positions are visible on the flange below each end of the rack.**

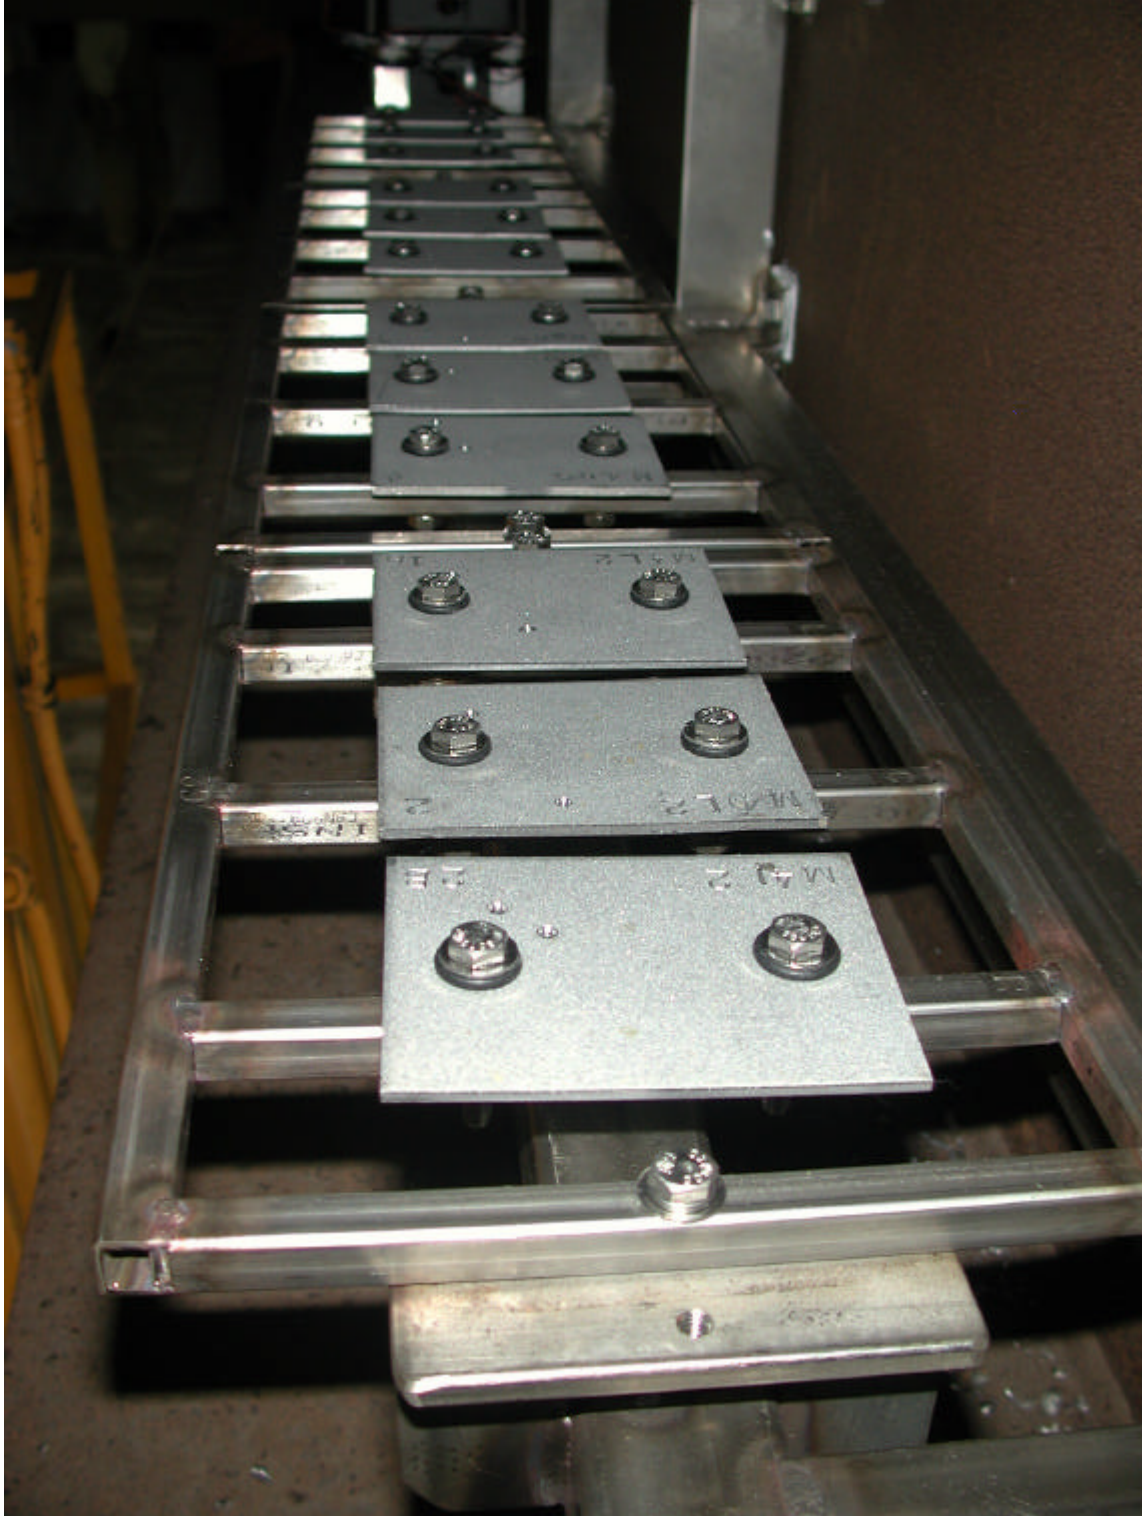
**Photograph 21:**  
**Specimen Rack 3 (end view) installed at location 3MN above the jogging path at the east abutment.**

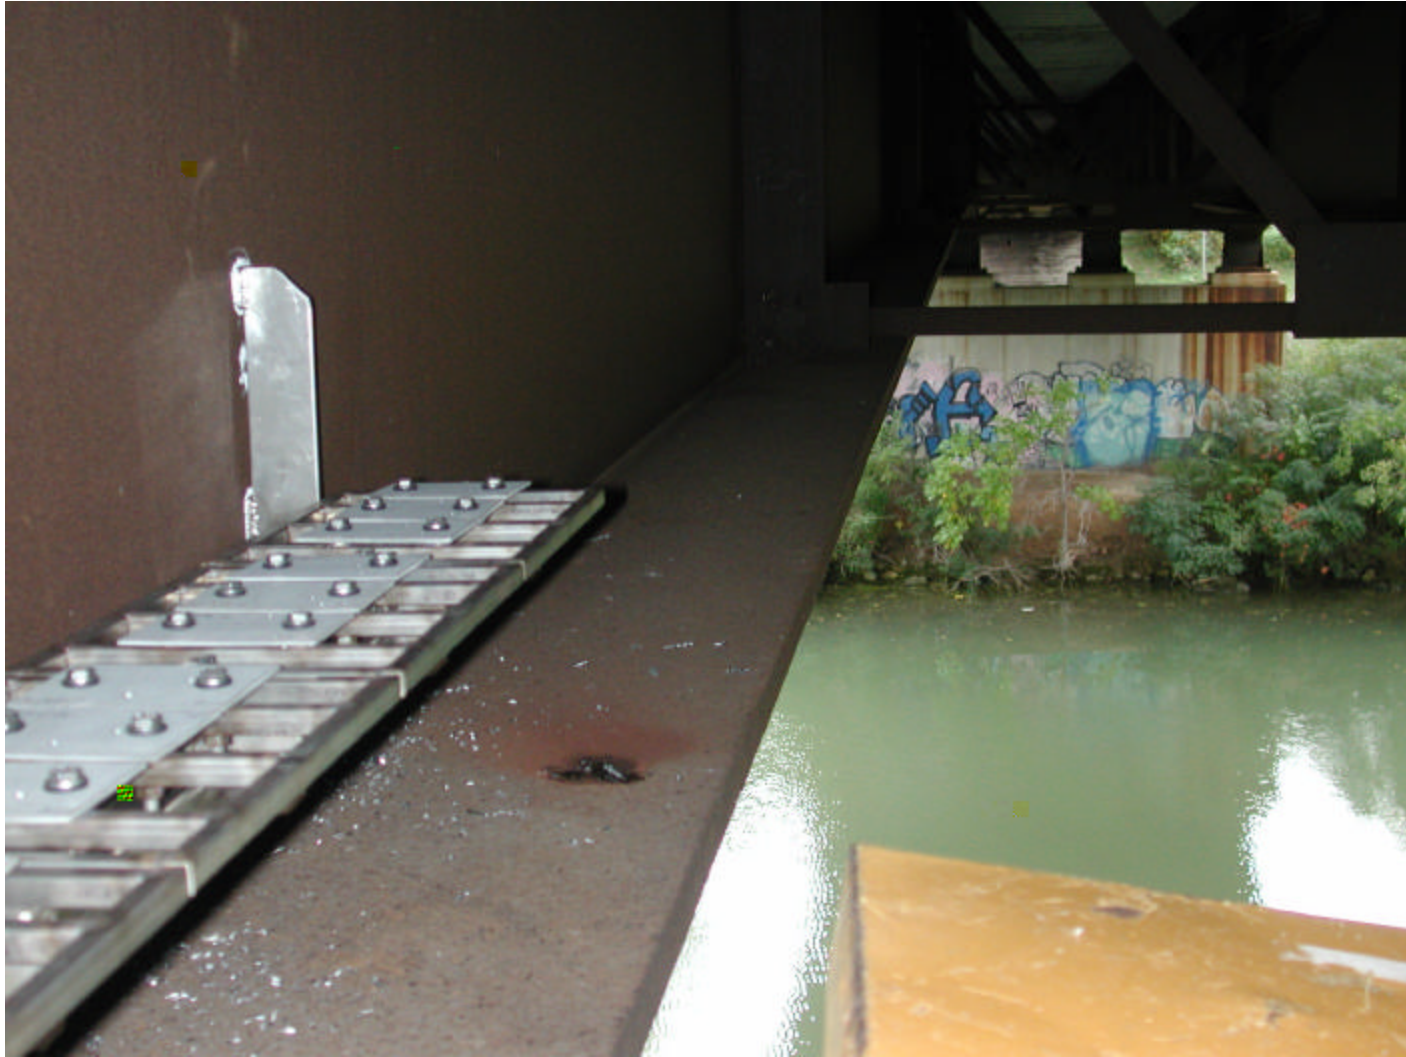
**Photograph 22:**  
**Specimen Rack 3 installed above the jogging path at the edge of the Erie Canal.**
